## Agenda

## West Lake Landfill

### 2008 WLL ROD Conceptual Design

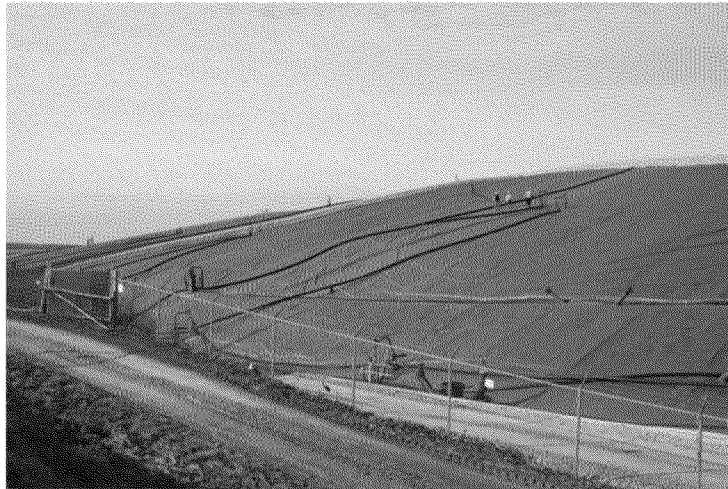
### **Bridgeton Geomembrane Cover**

According to EPA's Bridgeton Landfill website, all 42 acres of the South Quarry at the Bridgeton Landfill have been covered with a three-layer geomembrane (plastic) liner to capture odor and facilitate landfill gas collection. As shown, the liner has been placed on top of whatever soil/clay covering or cap already existed on the South Quarry.

I don't have specific information about the Bridgeton Landfill cap under the geomembrane shown on this slide. The next slide provides some information about typical nonhazardous and hazardous landfill caps.

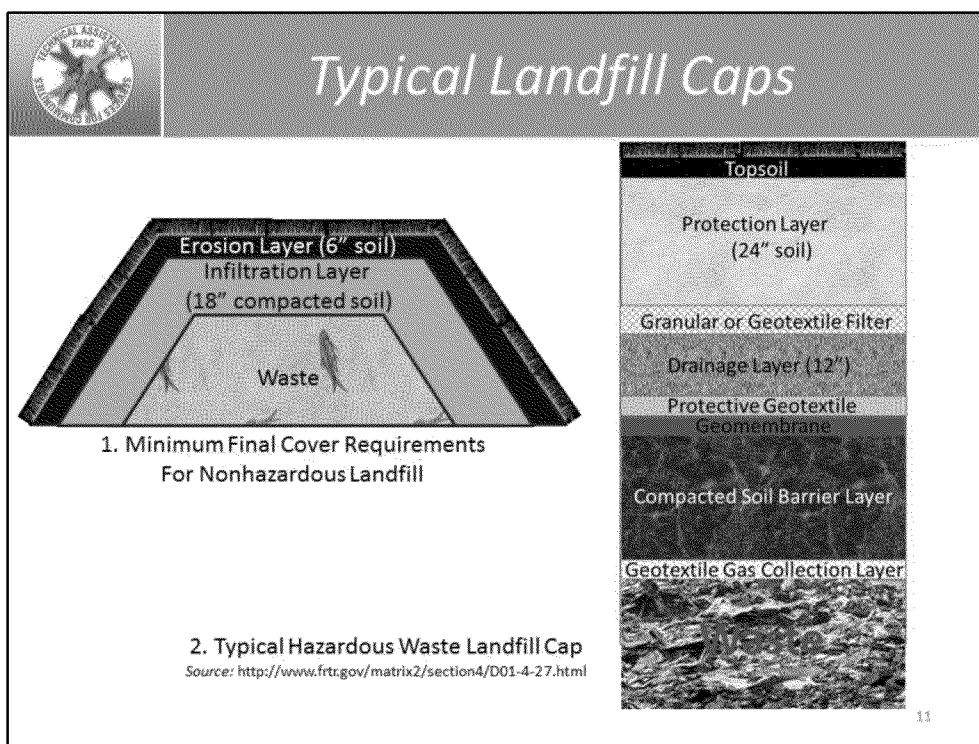
## Typical Landfill Caps

The figures on this slide show:

- 1) Minimum final cover requirements for a nonhazardous landfill. This type of final landfill cover is called a RCRA D landfill cover. RCRA stands for Resource Conservation and Recovery Act (RCRA).
- 2) A typical hazardous waste landfill cover, called a RCRA C landfill cover.

In addition to minimum cover requirements for RCRA D landfills, there are performance-based requirements that determine when the final cover for a landfill is adequate. Final cover requirements are intended to minimize erosion of the cover, prevent rainfall percolation into the covered wastes, and keep landfill gas from building up to unsafe levels or moving underground in a way that could endanger nearby structures.

This cover is similar to a nonhazardous landfill cover in that the minimum requirement for a RCRA D landfill cap is 2 feet of soil – 18 inches of compacted clay soil to prevent rainwater coming into the landfill and 6 inches of topsoil to establish vegetation. You may wonder why this particular landfill cover design is 5 feet deep.

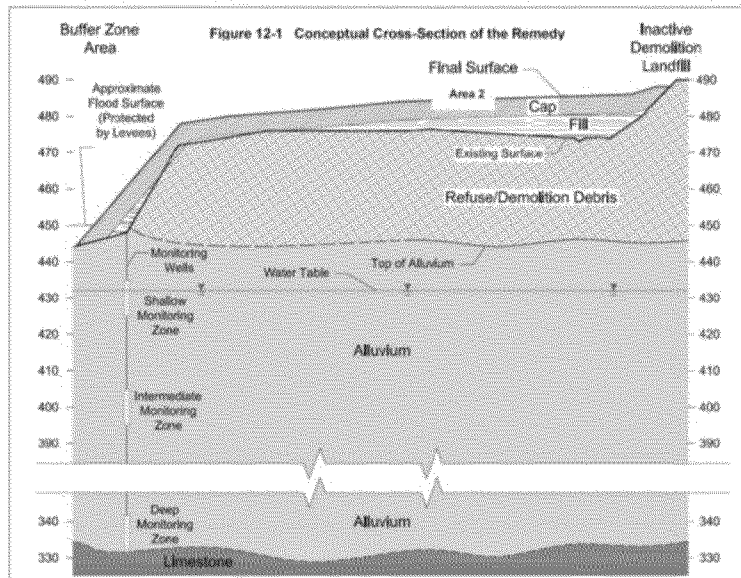
This is Figure 12-1 from the West Lake Landfill Superfund site 2008 Record of Decision (ROD). It shows a conceptual design of a landfill cap over Area 2 of OU-1. The cap is about 5 feet deep and consists of layers of rock or crushed concrete and compacted clay soil.

A diagram of the layers of the cap are shown on the next slide. It is important to remember that the information in the ROD is conceptual. If this remedy had been continued into a design phase, more analysis would have followed and more detailed information would be available.

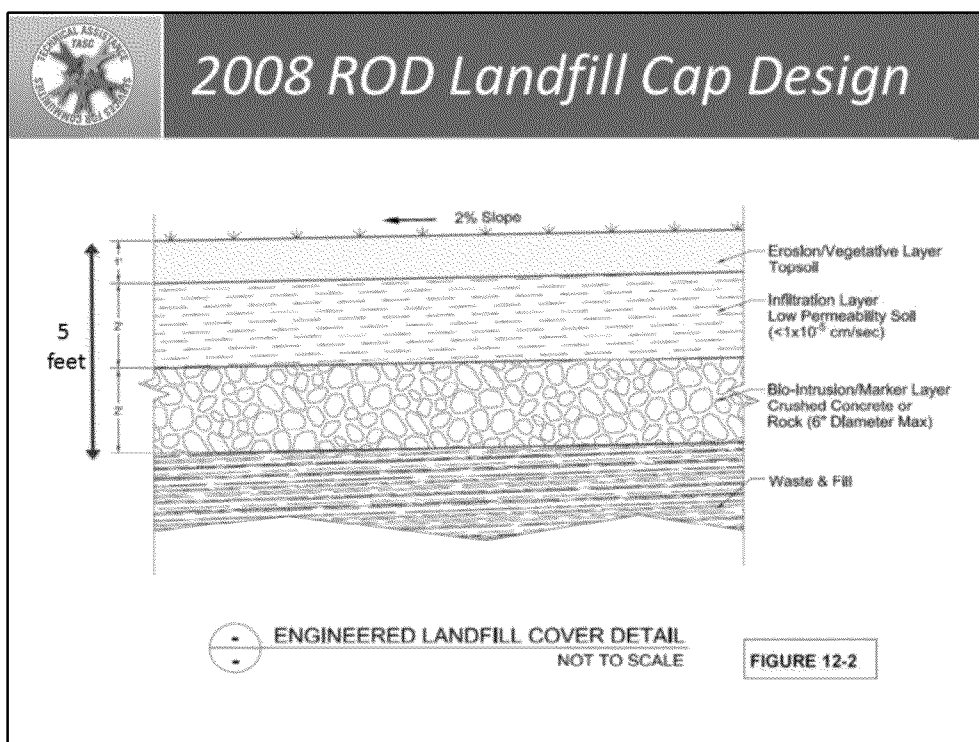
## 2008 ROD Landfill Cap Design

This is Figure 12-2 from the 2008 ROD. It shows that the 5-foot-deep landfill cap would consist of a 2-foot-thick bottom layer of crushed concrete or rocks with a diameter of about 6 inches directly over the waste material. On top of this layer, a 2-foot layer of compacted clay soil would prevent rainwater from percolating down through the landfill. The final top layer of the cap would be 1 foot of topsoil planted with short-rooted vegetation.

The 2008 ROD indicates that the purpose of the lowest layer of concrete or rock is to prevent bio-intrusion (plant roots and burrowing animals) and erosion, and to increase the longevity of the cap. Also, the cover thickness of 5 feet is needed to shield a person on the surface from gamma radiation exposure. We'll look at this on the next slide.

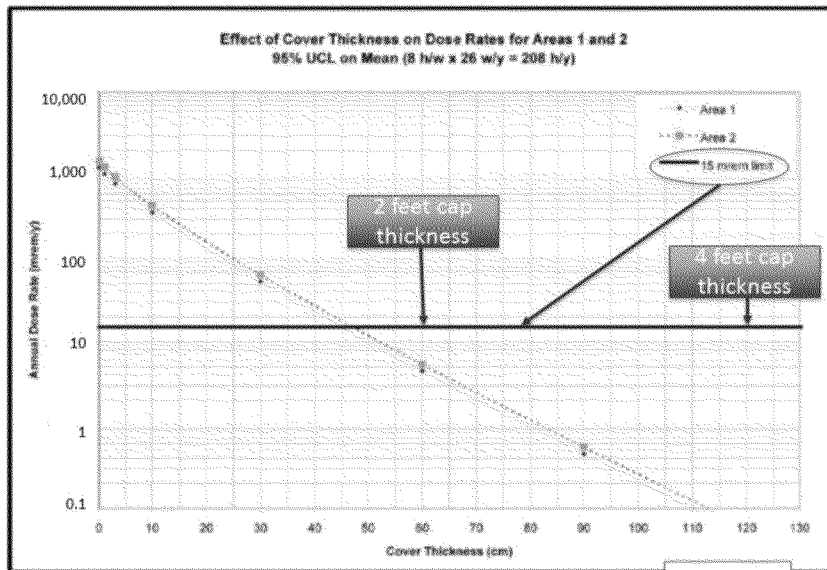
### Radiation and Cap Thickness

This is Figure 12-3 from the 2008 ROD. The sloped lines show the dose of radiation a person on the surface of the landfill will receive for different landfill cap thicknesses. The horizontal straight line is 15 millirem per year, which is the dose that EPA guidance indicates is typically considered acceptable for cleanup of Superfund sites.

You can see from the diagram that, at a cap thickness of 5 feet, people on the surface for eight hours per week, 26 weeks per year will be exposed to less than 15 millirem per year of radiation.

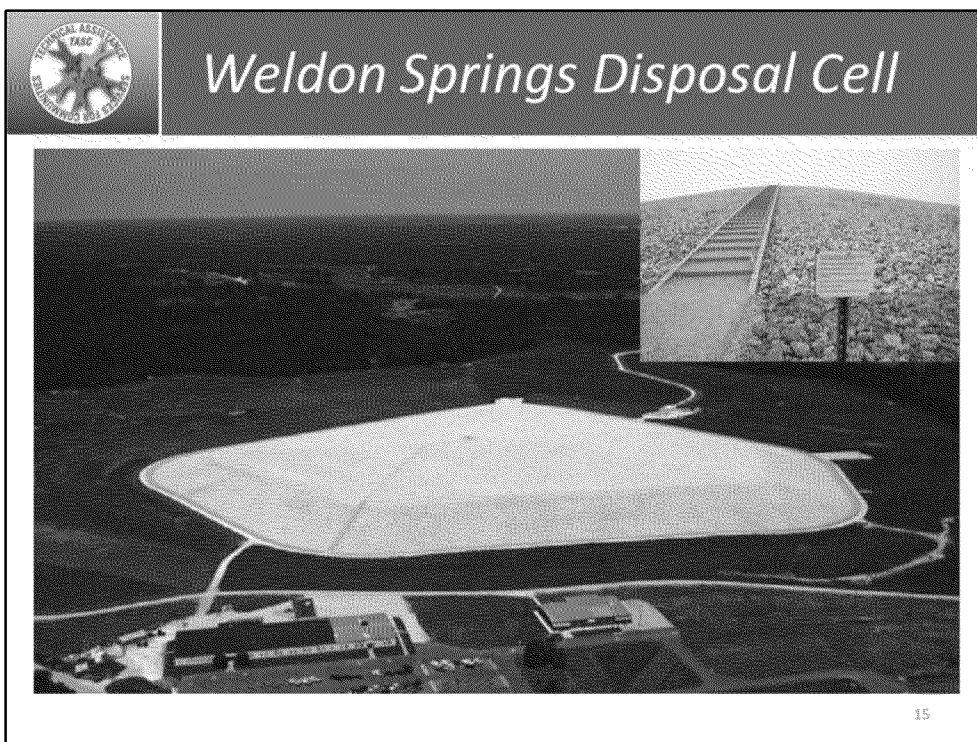
## **Weldon Springs Disposal Cell**

The Weldon Springs Disposal Cell was designed to receive radioactive wastes. It has a lined bottom, as well as the cap. It is designed to deter migration of contaminants and remain stable for 1,000 years. The Weldon Springs Site Interpretive Center website highlights these points:

- Engineered to resist long-term erosion and a precipitation event greater than has occurred in the recorded history of the region.
- Designed to withstand a Maximum Credible Earthquake (MCE).
- Located in a geologically stable area; not near earthquake faults.
